Huon Aquaculture Group Pty Ltd

Wastewater Reuse Environmental Management Plan

Parramatta Creek Fish Processing Facility

October 2019

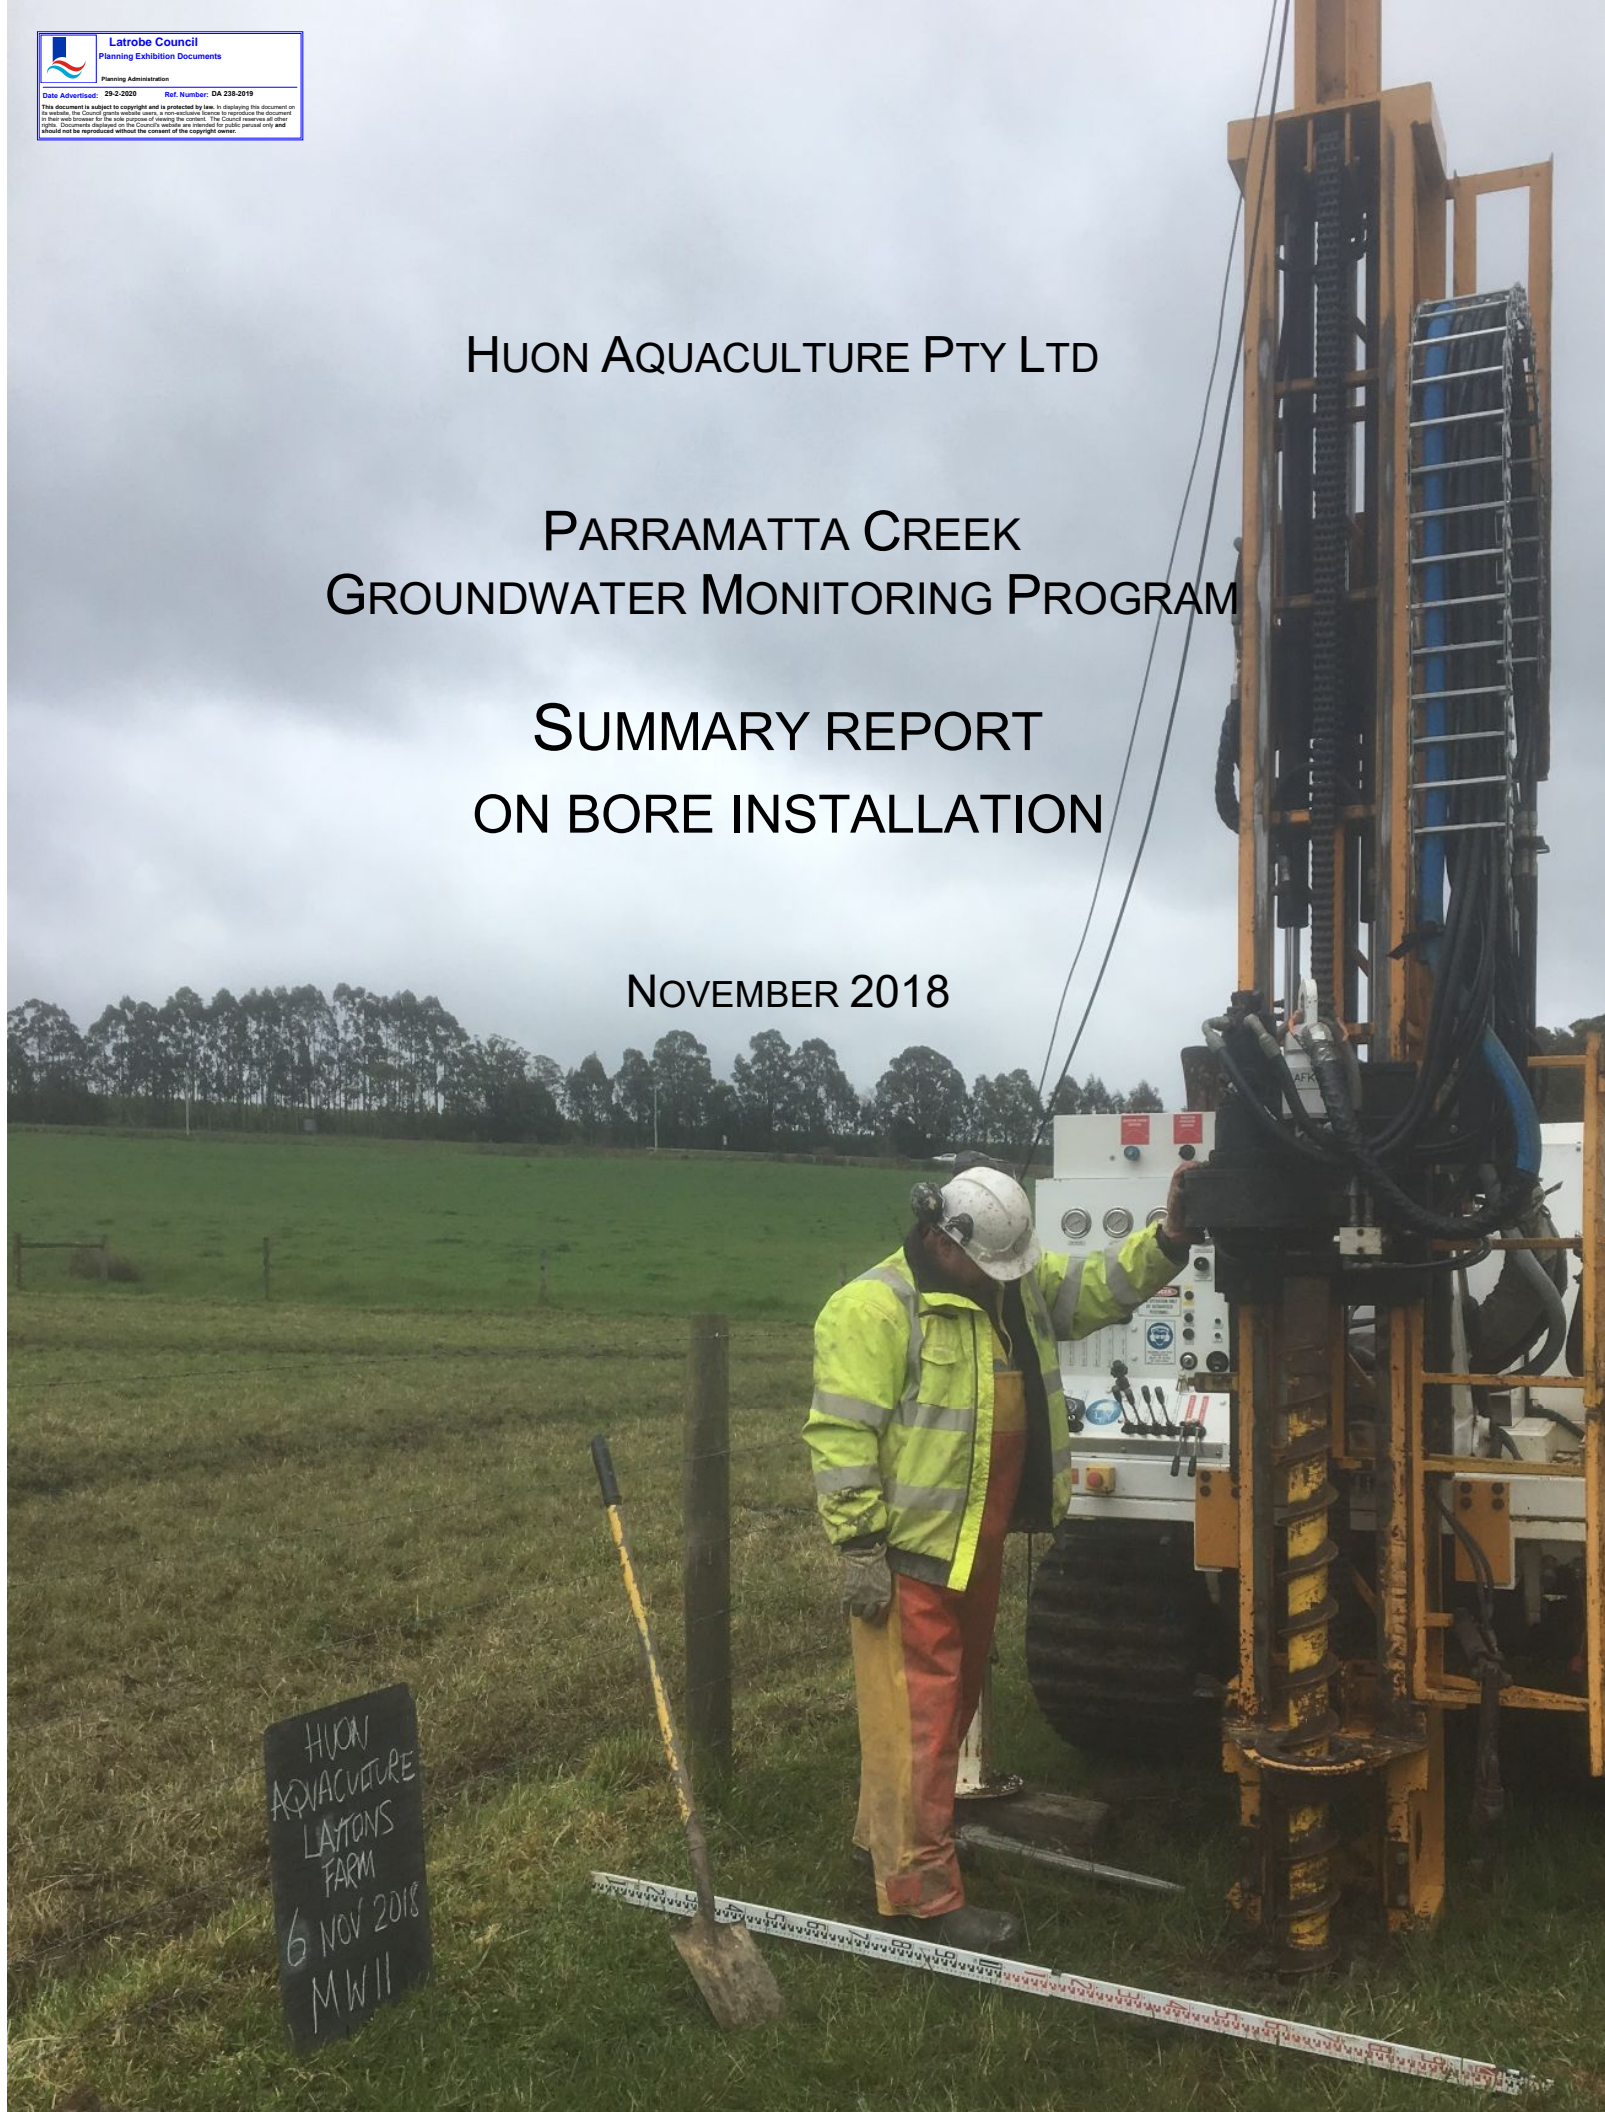
Cover photo (6 November 2018)

View looking west over part of Layton's Farm at Parramatta Creek, showing KMR Drilling's *Explorer 50* rig drilling monitoring bore MW11 with a 150mm diameter solid auger.
