Coastal Adaptation and Protection Options for Port Sorell and Shearwater

WRL Technical Report 2012/20
August 2012

**Coastal Adaptation and Protection Options
for Port Sorell and Shearwater**

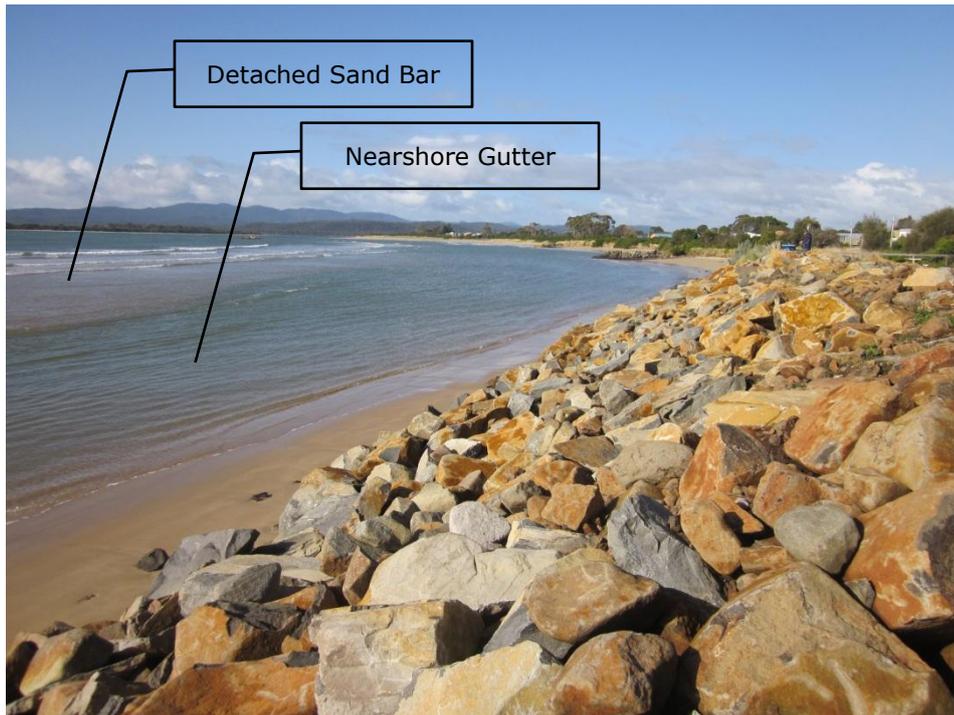
Figure 7: Rock Revetment at Location (1A)

- Predominantly igneous rock armour ranging approximately from 200 kg to 5000 kg;
- Crest level of approximately 4 m AHD (based on area behind crest being 3.5 m AHD as reported by Council from LiDAR measurements);
- Toe level of approximately 1 m AHD;
- Slope varying from approximately 1V:2H to vertical at the southern end of revetment.

There is no beach seaward of the revetment at high tide, and there is a nearshore gutter extending the length of the seawall and approximately 30 m seaward of the wall toe. A shallow sand bar exists further seaward, indicating that the revetment wall has likely exacerbated erosion of the nearshore beach with the sand from the beach laying in the detached bar. It should, however, be noted that while the revetment may have exacerbated erosion of the beach, it has likely saved the adjacent sewer pumping station from damage that natural erosion would otherwise have caused if protection works were not implemented.

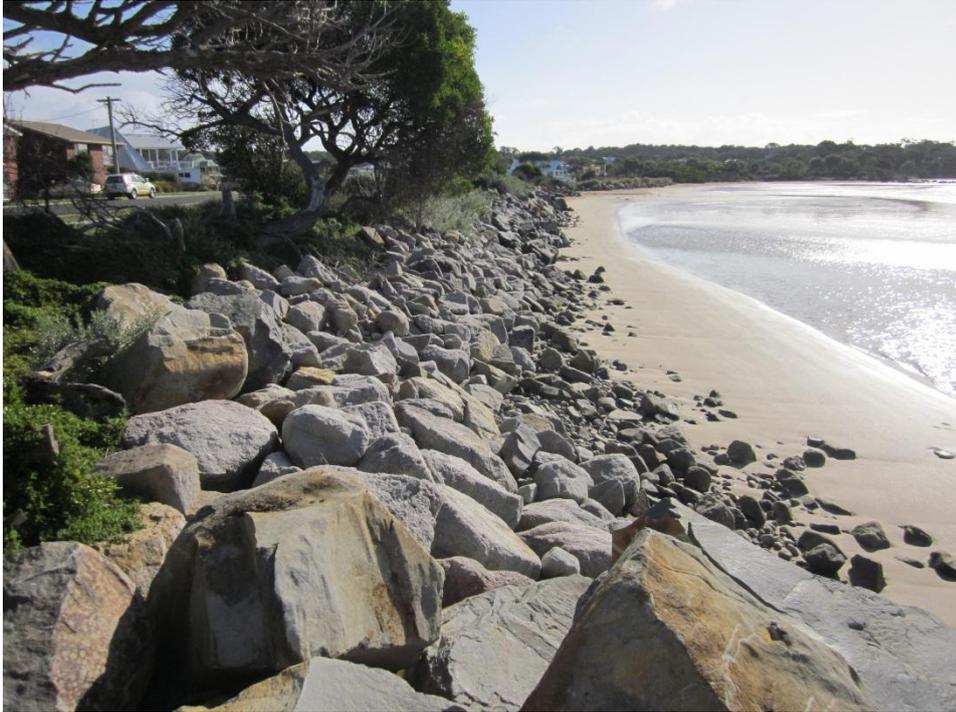
Figure 8: Rock Revetment at Location (1B)

Location (1B) at the end of Freer Street and to the north of the beach access is a rock armoured revetment wall that is believed to have also been constructed in July 2010 as an emergency protection measure. The revetment (shown in Figure 8) has the following characteristics:

- Predominantly lower quality conglomerate rock armour with typical size of approximately 20 kg to 500 kg, though some larger igneous stones up to several tonnes are also present;
- Crest level of approximately 3 m AHD and dropping further to the north;
- Toe level of approximately 1 m AHD;
- Slope of approximately 1V:2H.

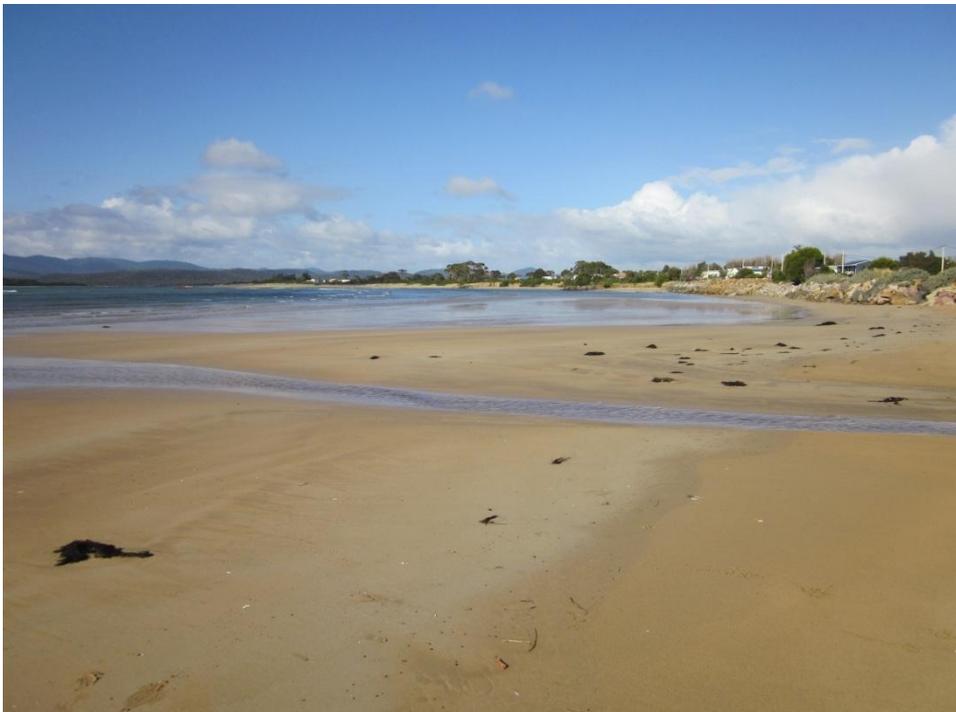
Figure 9: Beach at Location (2)

Location (2) at the northern end of Freers Beach is a sand flat area with a low vegetated dune backing the beach. This area has suffered less erosion than stretches of the beach further south.

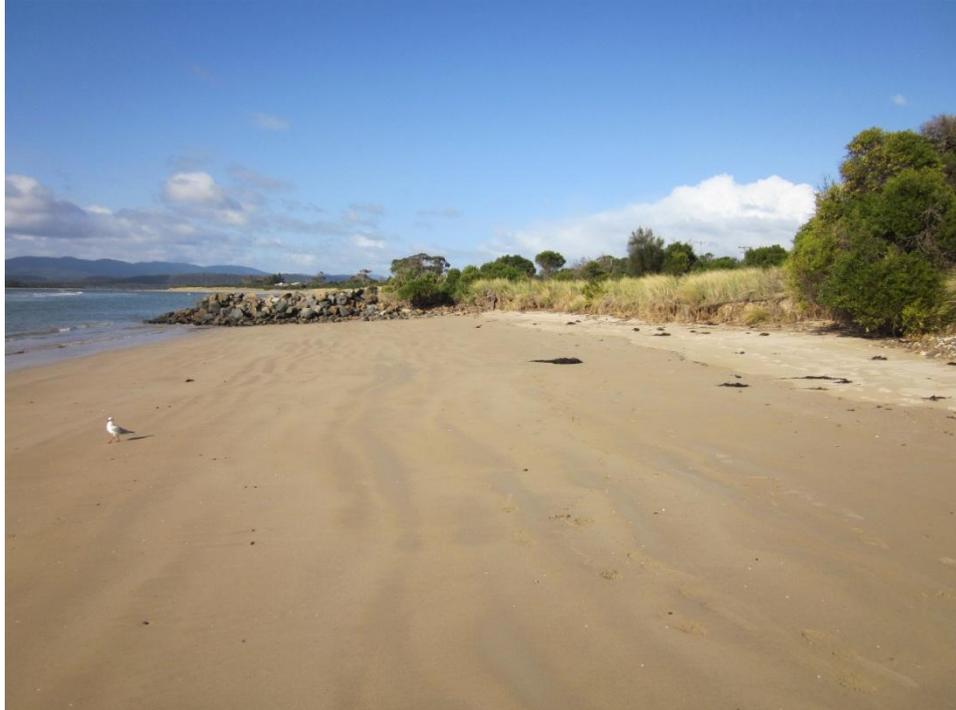
Figure 10: Beach Between Revetment (1A) and Stormwater Outlet (3)

The beach between Freer Street and the stormwater outlet at (3) is presently in a well eroded state (see Figure 10). There is very little sandy beach remaining above the high tide level, though the erosion is yet to create a scarp within the vegetated dune. The southern end of the revetment at (1A) is at risk of being outflanked and causing additional erosion in this area if a healthy beach is not re-established and erosion is allowed to continue.

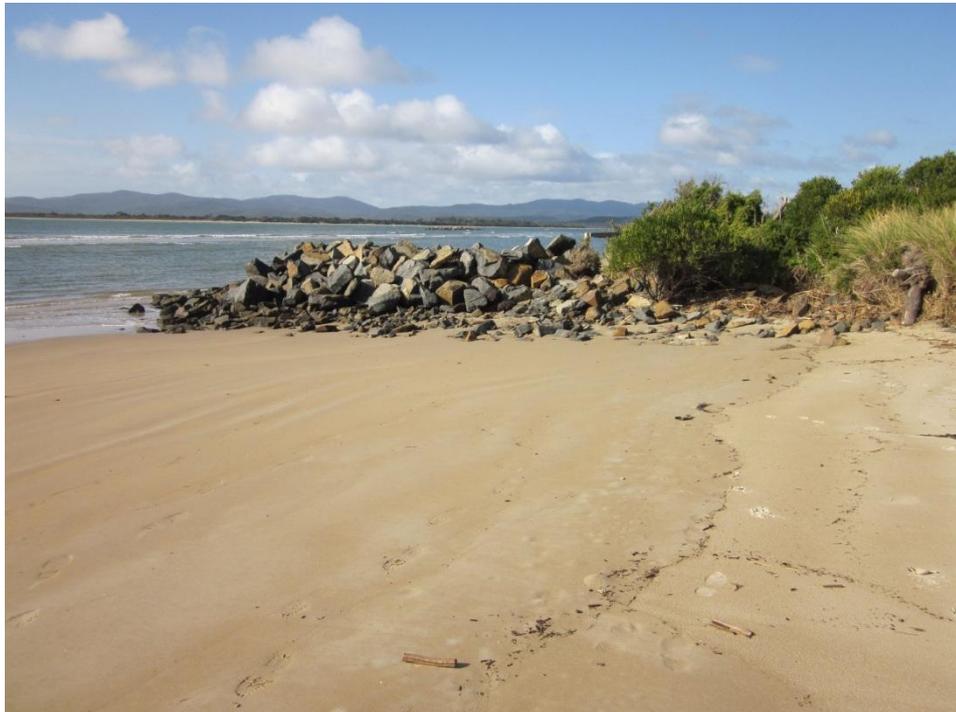
Figure 11: Rock Armoured Stormwater Outlet Structure at (3)

Location (3) is a stormwater outlet that terminates on the beach (see Figure 11). To help prevent sand from the beach blocking the concrete outlet pipe, a ring of rock armour has been built around the end of the pipe. The rock armour remaining intact on the structure ranges in size from approximately 150 kg to 3,000 kg, though there is a lot of smaller material that has been washed to the toe of the structure by waves. The rock armouring extends a distance of approximately 20 m seaward across the beach, with the structure effectively acting as a short groyne.

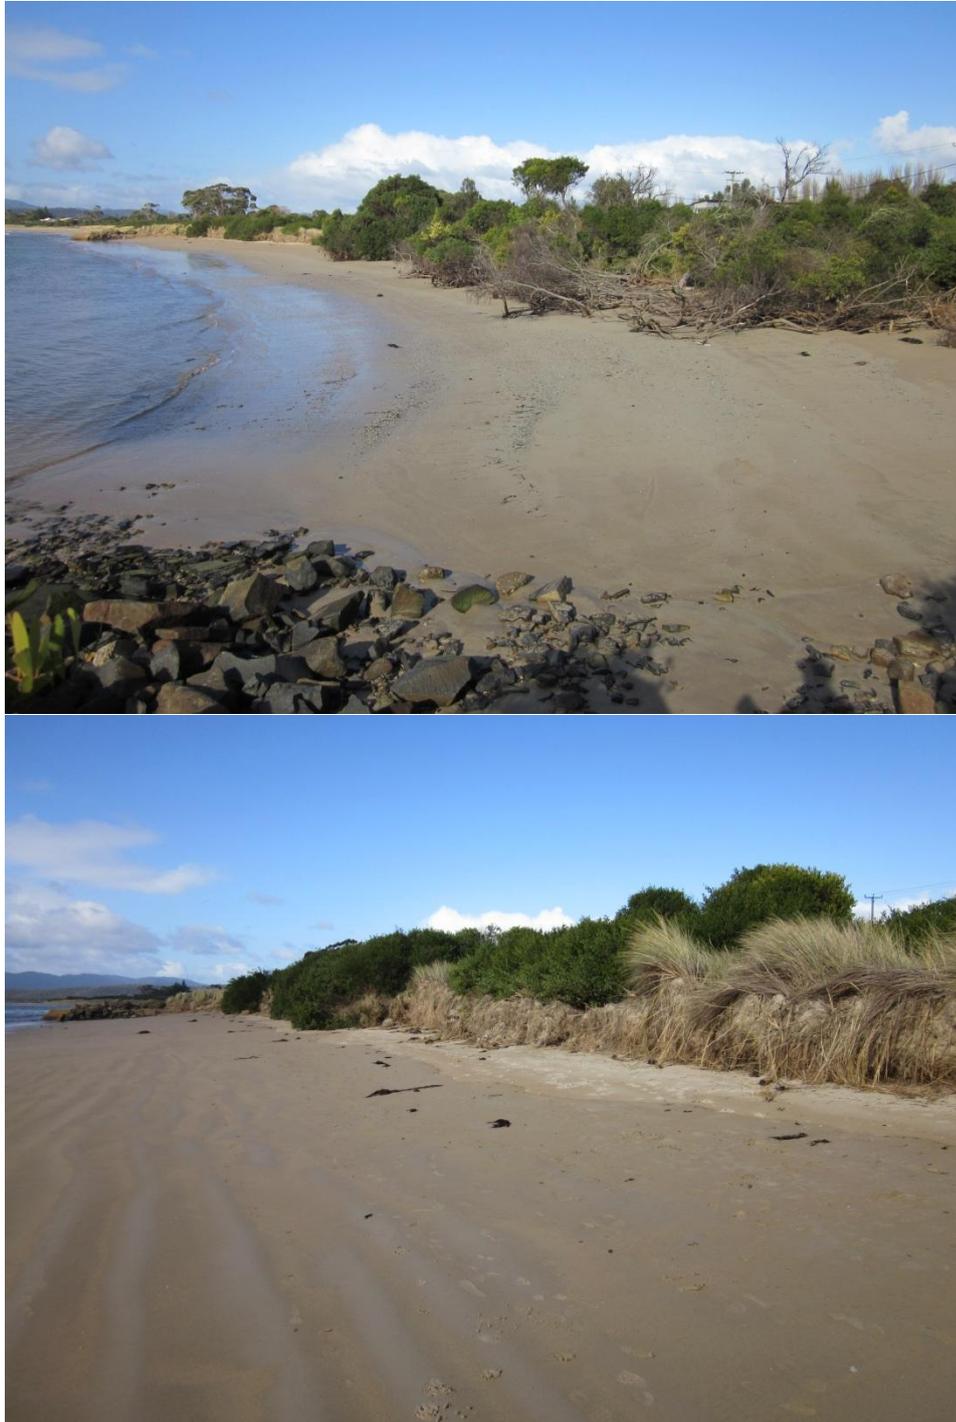
Figure 12: Eroded Section of Beach Between Stormwater Outlets at (3) and (4)

The beach between the stormwater outlet structures at (3) and (4) is in a heavily eroded state, with very little dry beach present at high tide. An erosion scarp of approximately 1 m in height is present along parts of this section of beach (see Figure 12 bottom), and a range of medium sized shrubs have recently collapsed from the dune onto the beach due to erosion of the sand from around their roots (see Figure 12 Top).

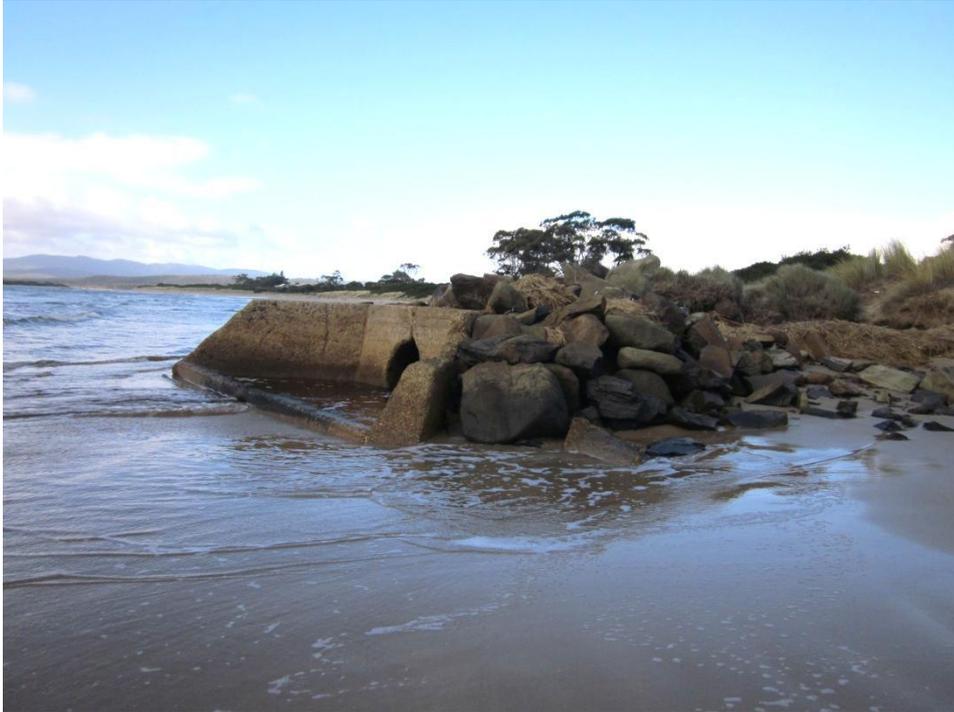
Figure 13: Stormwater Outlet at Location (4)

Location (4) is a stormwater outlet that terminates on the beach with a concrete headwall (see Figure 13). The outlet pipe has been armoured with rock in the past, though the purpose of the rock at this structure is not entirely clear. The rock armour remaining intact on the structure has a typical size of 200 kg to 3000 kg, though there is smaller material that has been washed to the toe of the structure by waves. The outlet extends a distance of approximately 15 m seaward across the beach, with the structure effectively acting as a very short groyne. Though not undermined at present, further erosion of the beach could see the headwall of this outlet undermined and damaged if works to protect the structure are not implemented in the near future.

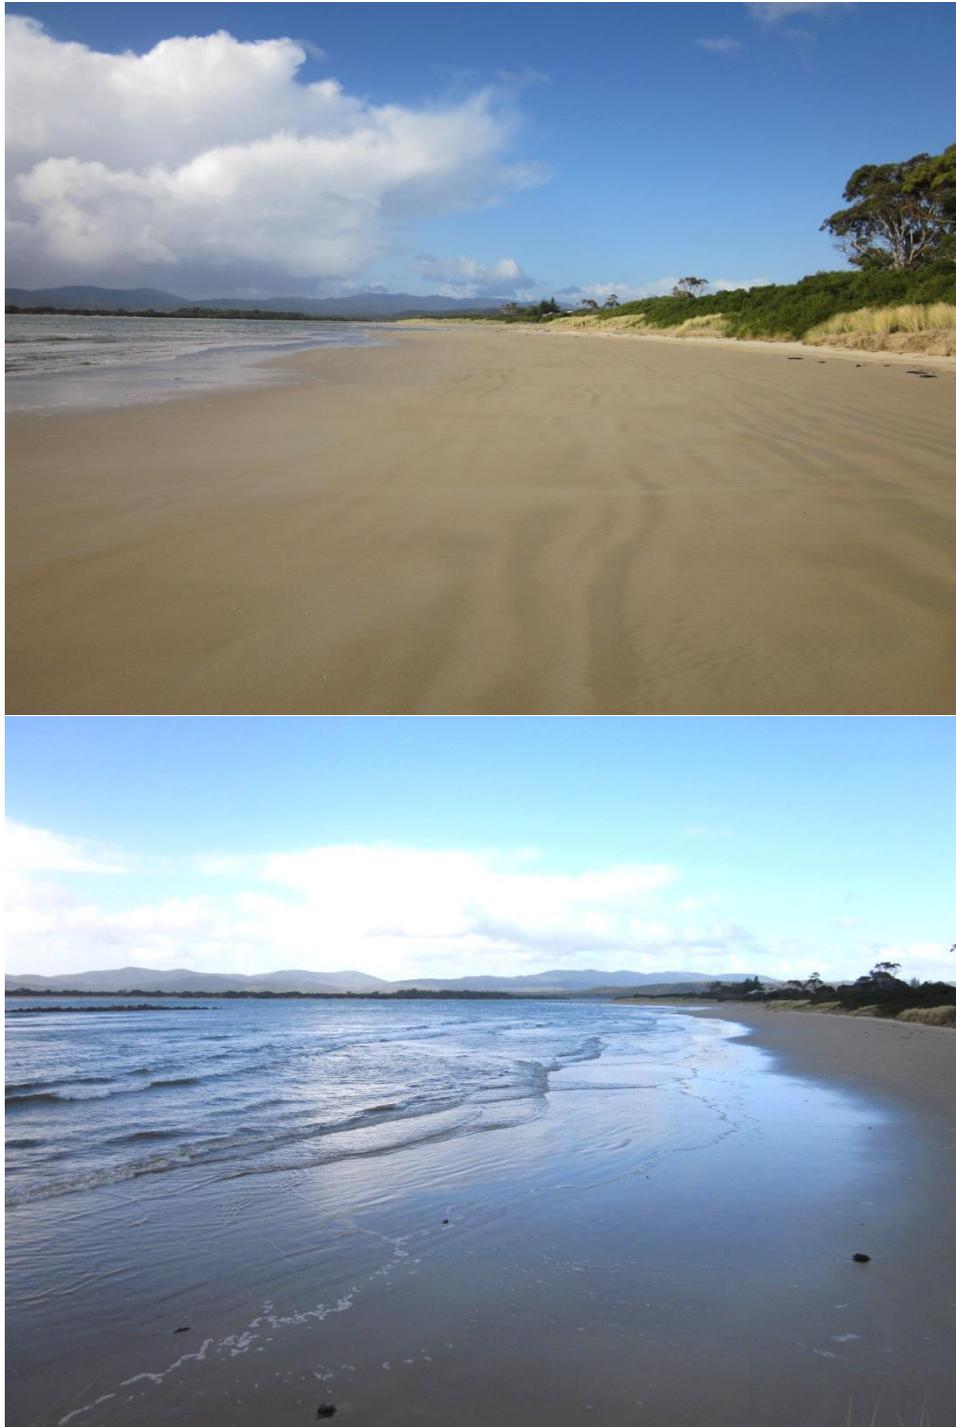
Figure 14: Beach Between Stormwater Outlet (4) and Offshore Breakwater (5)

The section of beach between the stormwater outlet (4) and the offshore breakwater (5) is also eroded, though to a lesser degree (see Figure 14). Though very little dry beach is present at high tide, there is no significant erosion scarp at present, and the erosion has not yet impacted the dune vegetation. The offshore breakwater (5, see Figure 15) is having a clear impact on the beach, with a salient of up to 10 m in width present. Based on discussions with a Council staff member who worked on the construction of the offshore breakwater, it was likely built around the late 1980s. It is understood that the armour was placed directly onto the sandy bottom, and that trucks were able to access the site to tip armour material during low tide. It is estimated that the offshore breakwater (5) has the following characteristics:

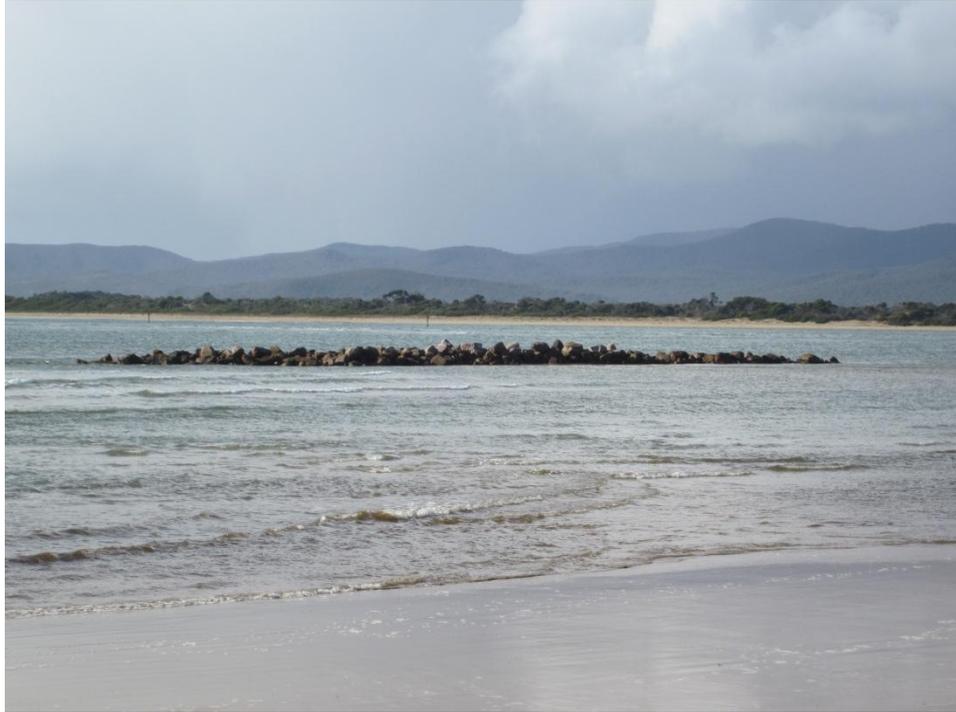
Figure 15: Offshore Breakwater (5)

- Crest level ranging from MSL at ends up to 1.5 m AHD in centre;
- Crest length (longshore) of 100 m;
- Distance offshore of 150 m;
- Armour stone size of 5000 kg to 7000 kg;
- Toe level of -1 m AHD.

It is understood that the breakwater had a more substantial crest after construction, but has lost armouring material over time due to wave attack. This structure was also planned to be built as the centre structure in a field of three structures, however, the outer two structures were never completed.

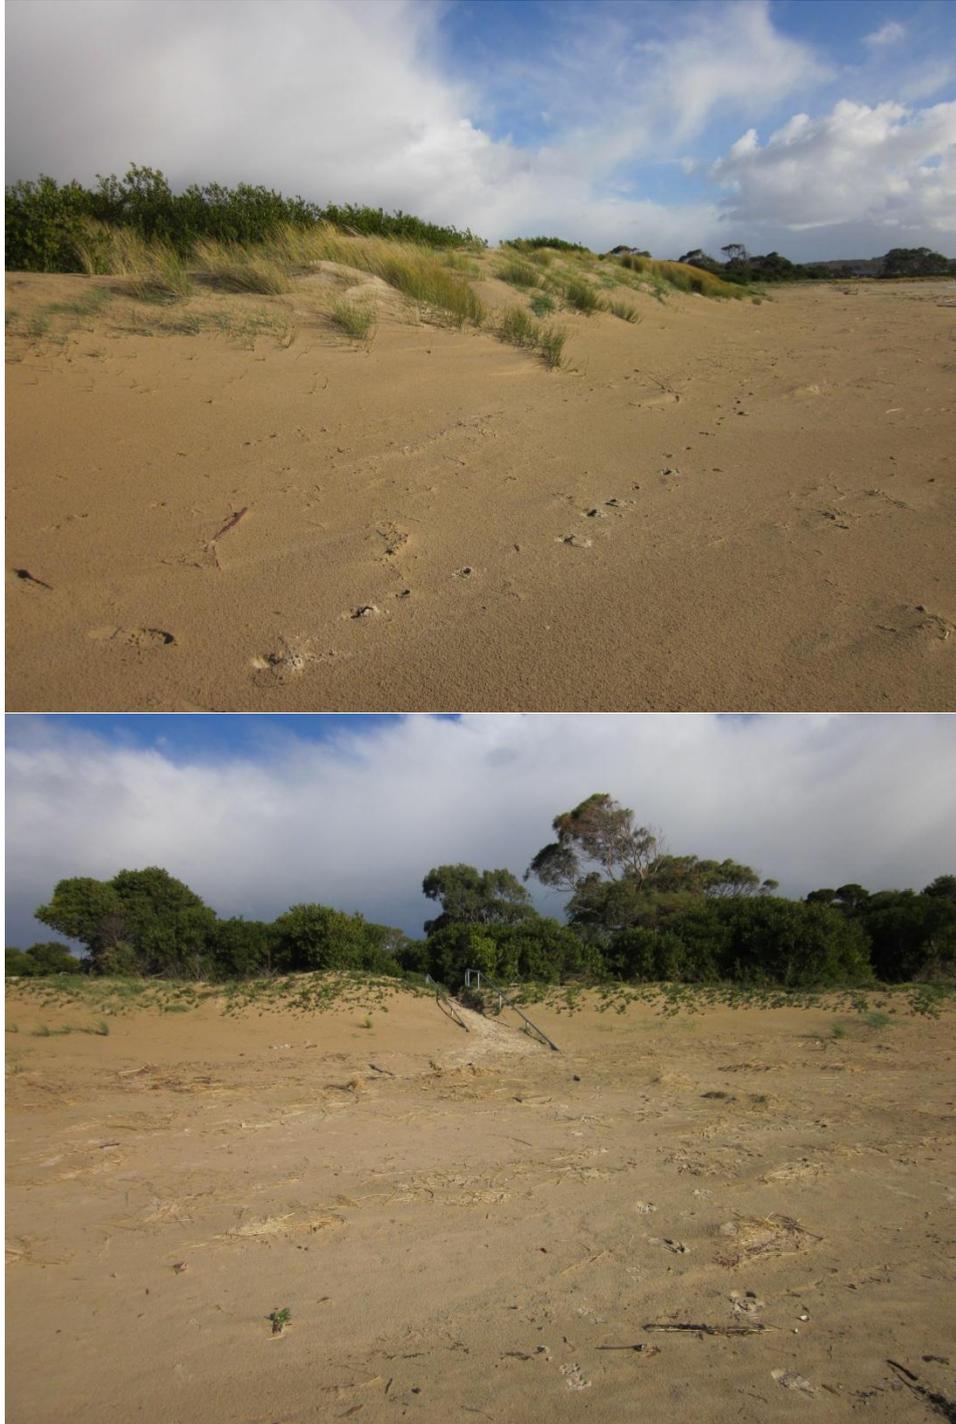
Figure 16: Accreted Beach Between Offshore Breakwater (5) and Stormwater Outlet (6)

South of the offshore breakwater (5) and north of the stormwater outlet (6), the beach has had significant recent accretion (between Anderson Street and Rice Street). The beach in this area has a well-established and vegetated back beach dune and is significantly wider (approximately 50 m) than the sections further north. Just seaward of the dune a significant quantity of loose sand has been freshly deposited during recent storms, with the deposition so deep in places that a previous beach access way and dune vegetation has been partially buried (see Figure 16 Bottom). It is postulated that this is the sand recently eroded from sections of beach north of (5).

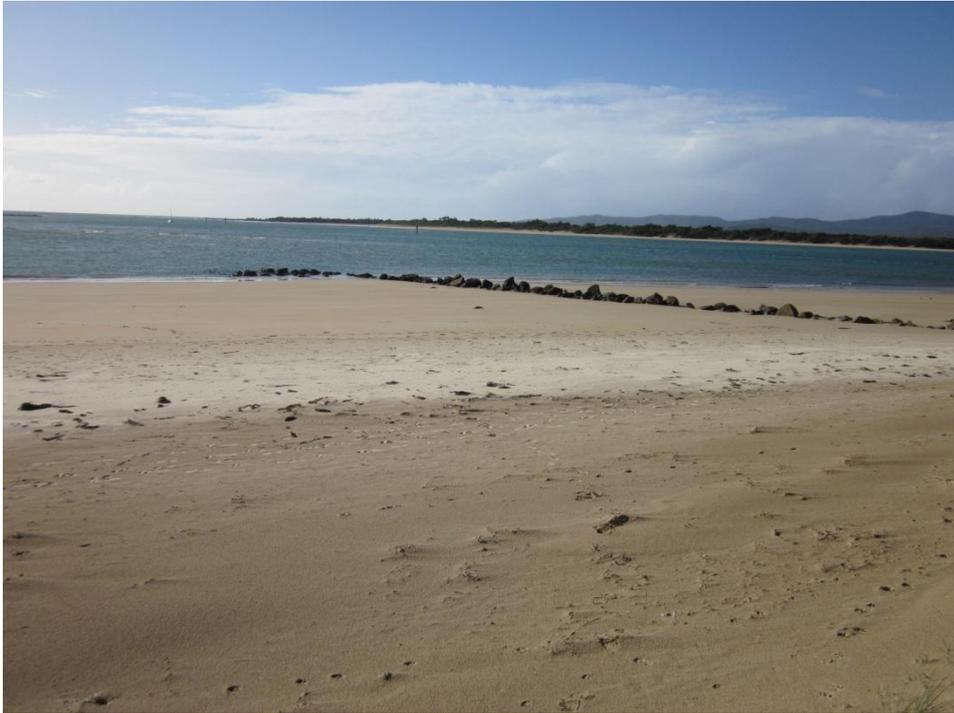
Figure 17: Groyne Structure Crossing Beach at Location (6)

Location (6) at present appears to be a rock armoured groyne structure that extends some 75 m seaward across the beach, ending with a perpendicular hook at its seaward end (see Figure 17). The beach has filled against the groyne to such a degree that only the upper 0.2-0.5 m of rocks are visible above the sand. Due to the overfull beach at this location, it would appear that almost all littoral drift sand transport would directly bypass this structure.

Upon consultation of older aerial photographs of this site, it is believed that this groyne structure is actually on top of an old stormwater outlet. Regardless of the origin, it is likely that this structure has been trapping littoral drift sand for at least the past 20 years (until it reached its present full state) and has significantly re-shaped this section of the beach.

The coast changes alignment significantly at this location (6) from east-west to north-south.

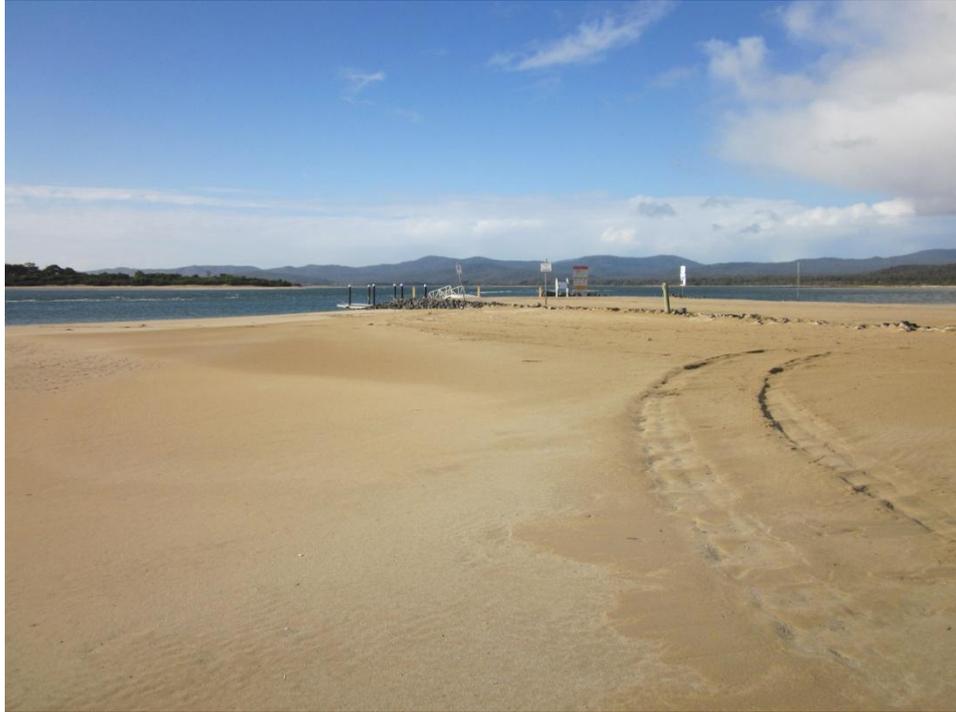
Figure 18: Healthy Beach Adjacent to Boat Ramp at (7)

South of (6) the beach is in a relatively accreted state through to the boat ramp and pontoons at (7, See Figure 18). This stretch of beach is completely sheltered from wave attack (aside from local wind driven seas on the estuary), and appears to have a healthy supply of sand. Despite having completely different alignment to the beach further north, the sediment on the beach is still consistent in appearance, suggesting that it is likely a part of the same sediment compartment. South of (7) Marys Creek crosses the beach, and there is a clear change in the appearance of the sediment at location (8). It is apparent that the sediment at location (8) contains a higher fraction of estuarine silts and is also darker in colour, so typical of estuarine mud flat areas. It appears that the clean marine sand at location (7) differs in nature to the estuarine sand at (8), and therefore likely indicating the closure of the marine sand cell of Freers Beach at location (7).

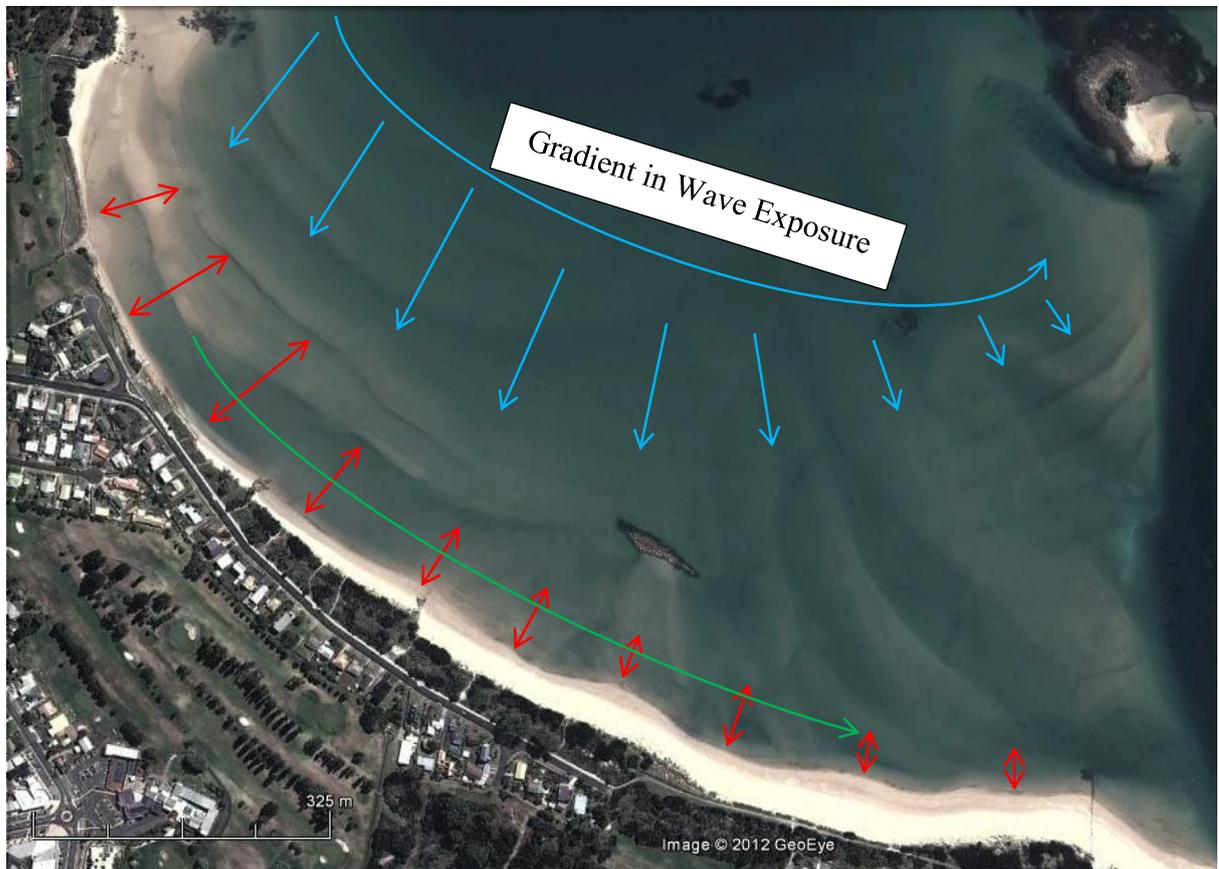
Figure 19: Wave Exposure and Sediment Transport Processes

The site is exposed to wave energy from Bass Strait propagating into the estuary during north-easterly wave conditions. Due to the aspect of the entrance as well as the presence of Penguin Island, there is a natural gradient in wave energy entering the estuary entrance as shown in Figure 19. This gradient in wave energy likely results in higher levels of cross-shore sediment transport during storm conditions (storm bite) for the area between locations (2) and (4) on Figure 5, and a general tendency for long-term littoral drift from the north-west end of Freers Beach toward the south-east. It is also probable that sand removed off the active beachface during storms at the northern end of the embayment is pushed south-east along the embayment and deposited in the area between locations (4) and (6) on Figure 5. This process has throughout time likely created an imbalance in available beach sediment at the north-western end of the beach and a surplus of sand at the south-eastern end of the beach through a combination of underlying littoral drift and short term storm erosion.

The existing coastal structures installed at the site (thought to be in the late 1980s or early 1990s) provide further confirmation of these sediment transport processes. Clearly this stretch of coast has been dynamic and suffered from erosion in the past, as there is evidence of back beach protection in the form of gabion baskets, as well as a groyne (6), stormwater outlets (3 and 4), an offshore breakwater (5), and mostly buried rock revetments extending from (5) to

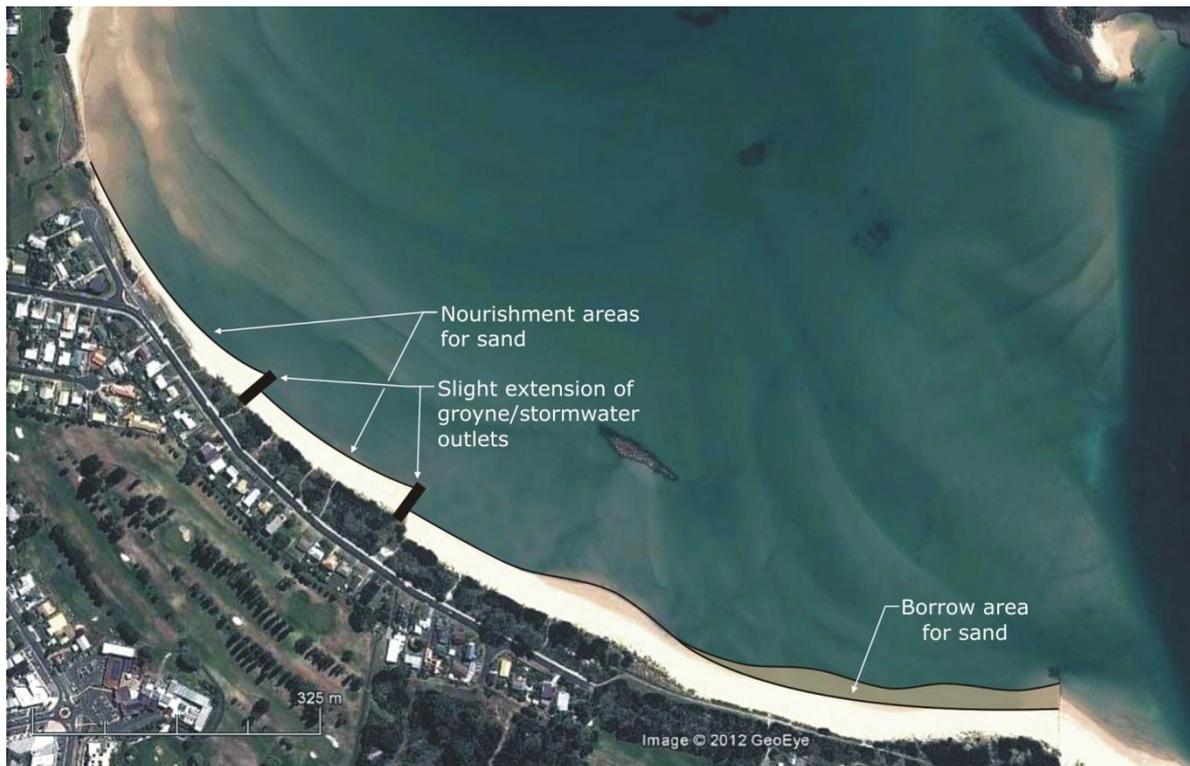
Figure 20: Schematic of Conceptual Short-Term Strategy

While calculation of the exact littoral drift sediment transport rate along Freers Beach is beyond the scope of this project, it is expected to be substantial enough to reduce the effectiveness of any nourishment sand placed over the north-western end of the beach, unless additional structures are built to retain the sand. This is typically facilitated through the construction of groynes across the beach, which to a certain degree have already been established through the armouring of the stormwater outlets at (3), (4), and (6). The rock armouring of the groynes at locations (3) and (4) could be extended by a suitable distance to retain the nourished sand. As a guide, the groyne at location (6) is approximately 75 m long and has created a beach that is more than adequate in width. As a trial option the groynes at (3) and (4) could be extended from 15 – 20 m length to being 30 – 40 m length.

Caution should be taken when establishing the exact length of the groyne extension, as extending the structures too far seaward will begin to trap additional littoral drift sand on the beach (beyond that placed through beach scraping nourishment), and in the longer term may starve the downdrift sections of beach from a sand supply. This would eventually result in erosion of the beach at the south-eastern end of the embayment. It is recommended that the groynes only be extended to the distance required to retain the nourishment sand, so that the compartments between the groynes are “pre-filled” and additional littoral drift sand is not captured.

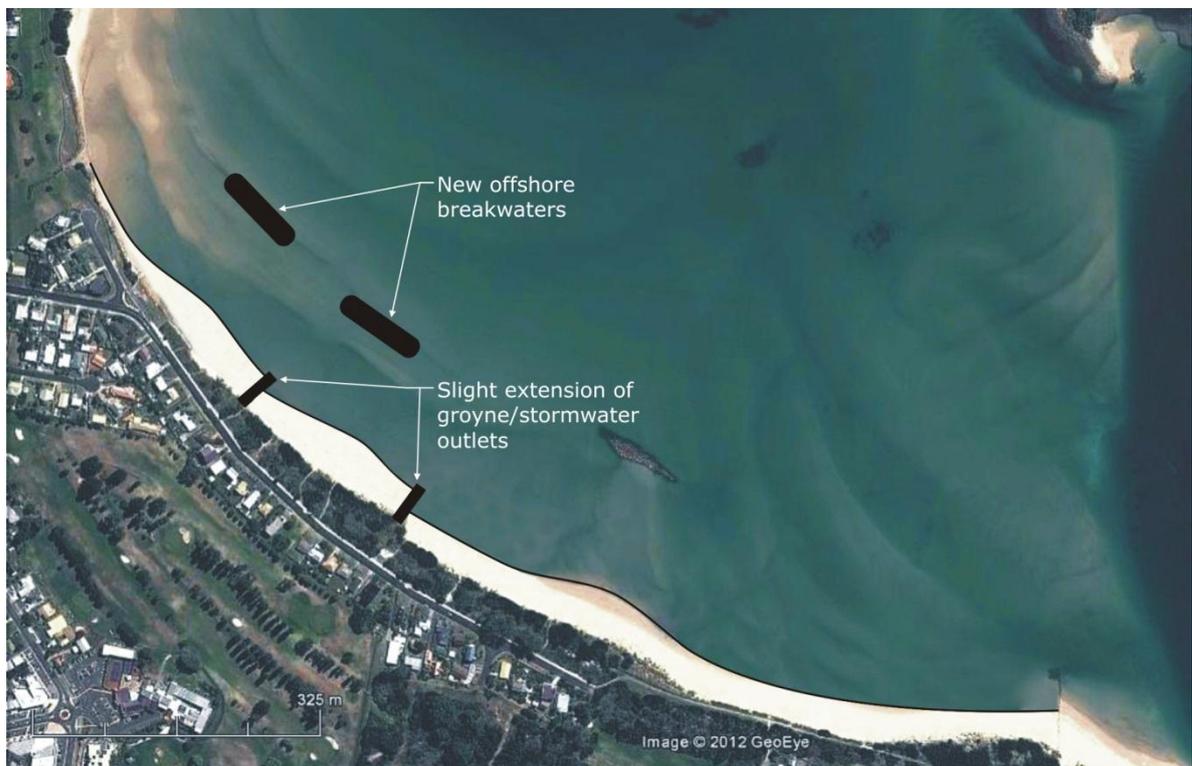
Figure 22: Schematic of Third Conceptual Long-Term Strategy

The second and third long-term management options are shown schematically in Figure 21 and Figure 22 on the following page. It is expected that the second option could be implemented for a cost of the order of \$220,000, while the cost of the third option would be of the order of \$420,000.
